Cross-Sectional Data

Photographs

The following links contain photographs of selected cross sections of defects made during this program. These defects were made using a spherical indenter with a sharp protruding "tooth".

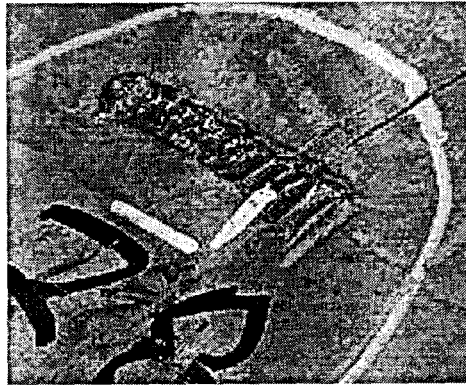
DEFECT #28

Dent Depth=0%
Gouge Depth=25% (target)
Length=2 inches
Pressure=60% SMYS
Sharp Cutter

Photograph of Defect

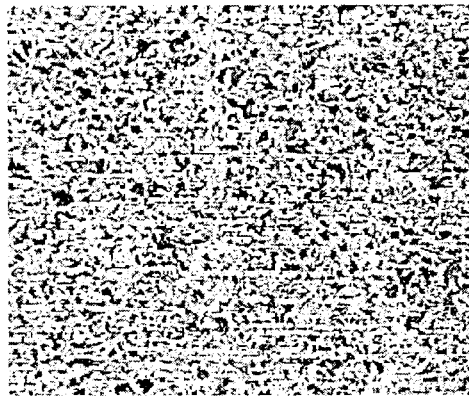
Base Metal at 100X Magnification

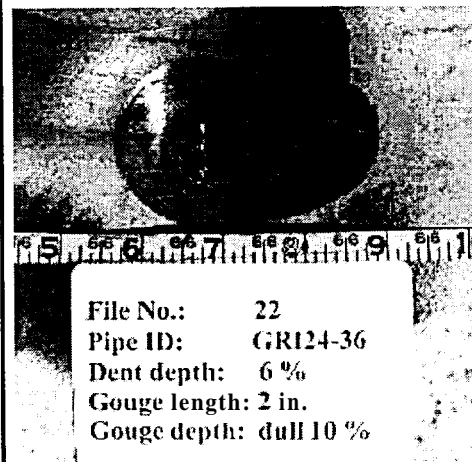
DEFECT #31

Dent Depth=6%
Gouge Depth=10% (target)
Length=2 inches
Pressure=60% SMYS
Dull Cutter

Photograph of Defect

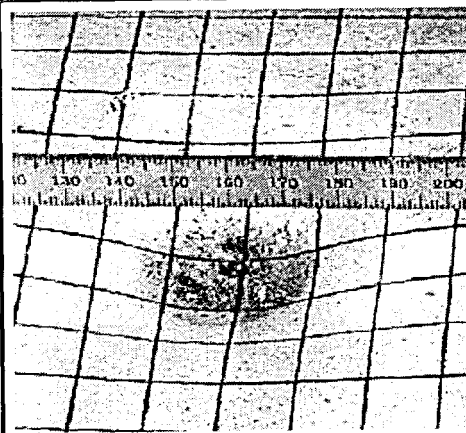
DEFECT #D08-7
0.5 inch deep Dent
Elliptical Indentor

Photograph of Defect

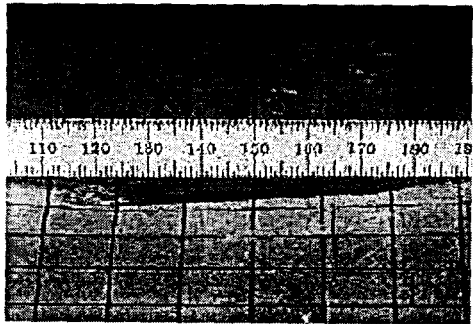
DEFECT #G08-4
2-inch Scrape with little denting

Photograph of Defect
